**WILLIAMS LAKE DAM**

MA. 00451

**PHASE I INSPECTION REPORT  
NATIONAL DAM INSPECTION PROGRAM**

DECEMBER 1980

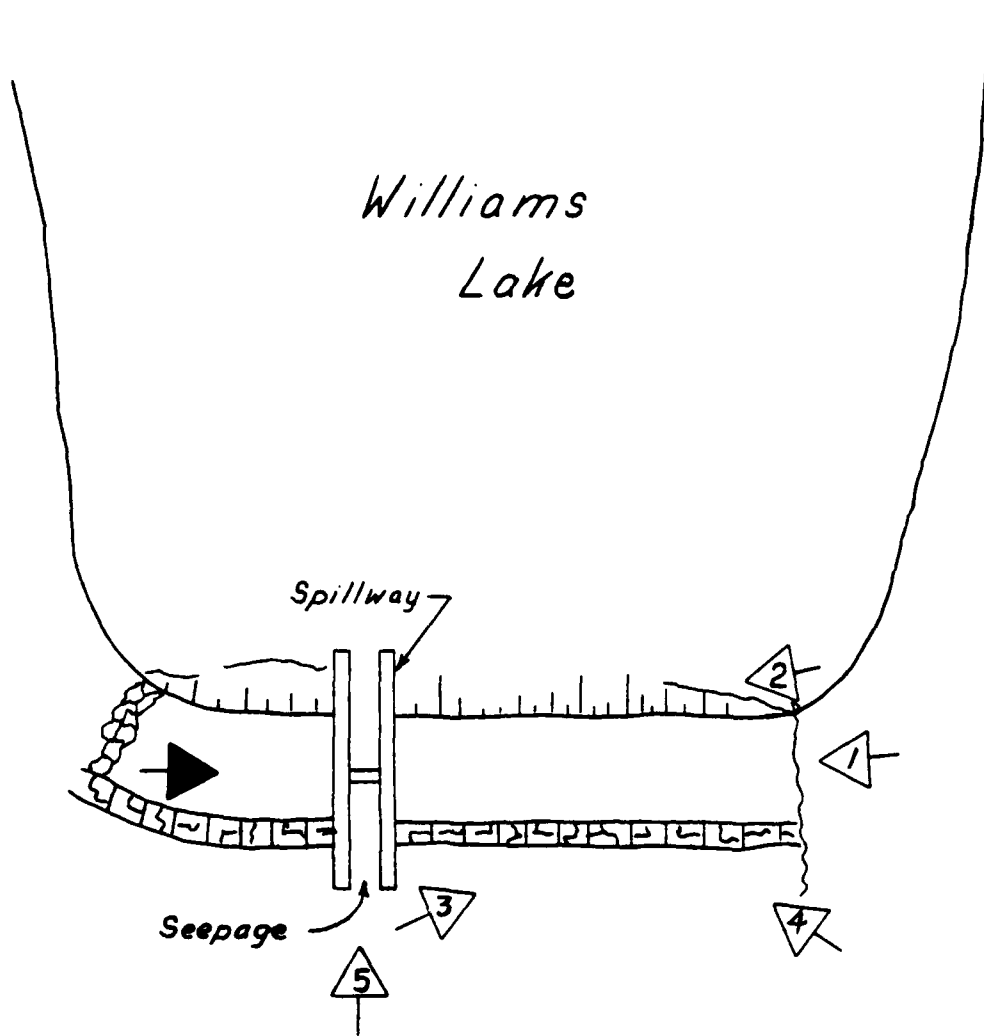
2. Brush and tree growth on upstream slope.

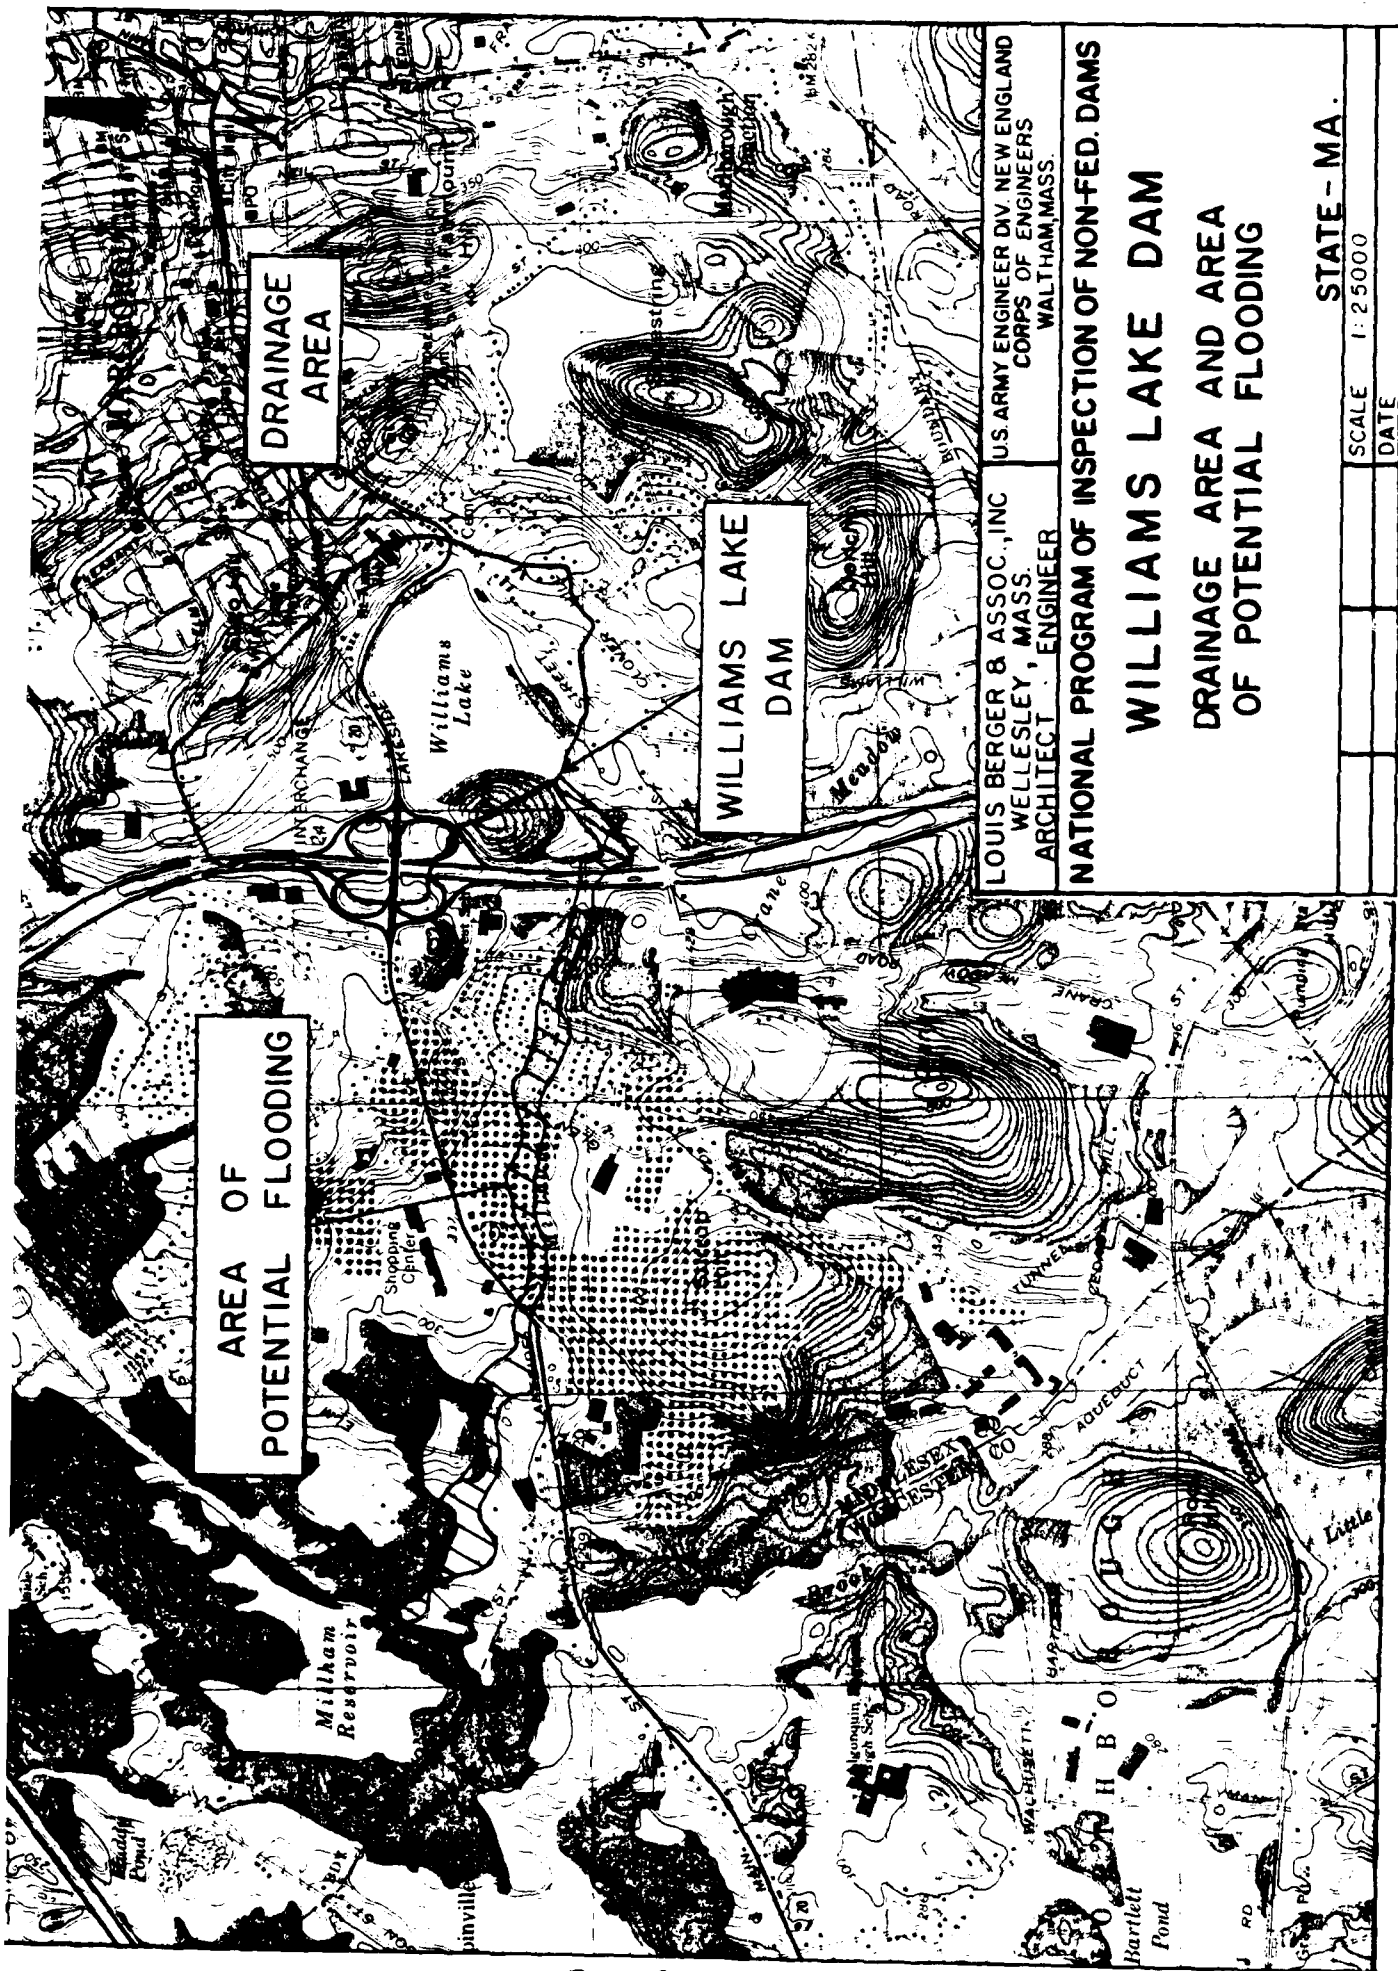
AREA OF  
POTENTIAL FLOODING

WATER WILL BE ABOUT 2 FT DEEP IN GLEN ST HOUSING DEVELOPMENT, FLOODING ABOUT 20 HOMES IN BASEMENTS AND SEVERAL STREETS.
